Coal Combustion Waste Impoundment

Round 7 - Dam Assessment Report

Walter Scott Junior Energy Center

MidAmerican Energy
Council Bluffs, Iowa

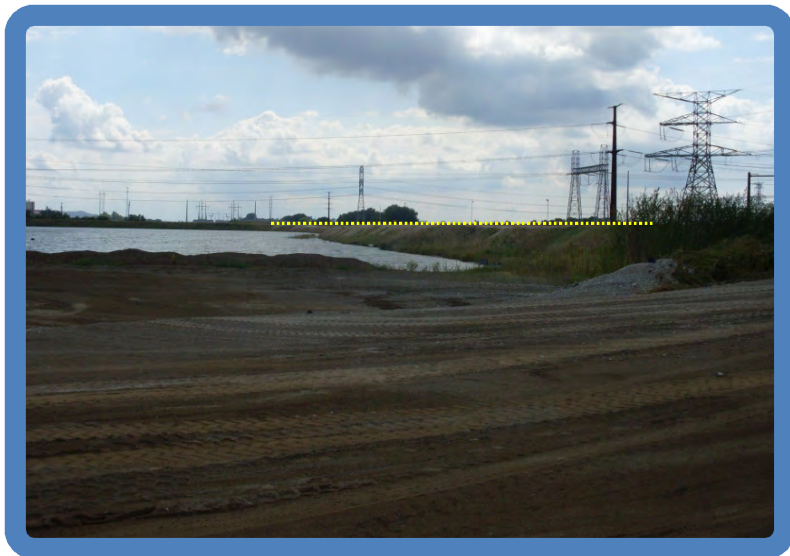
Photo S.1.a
South Pond (from near top of mound) (viewed NE)

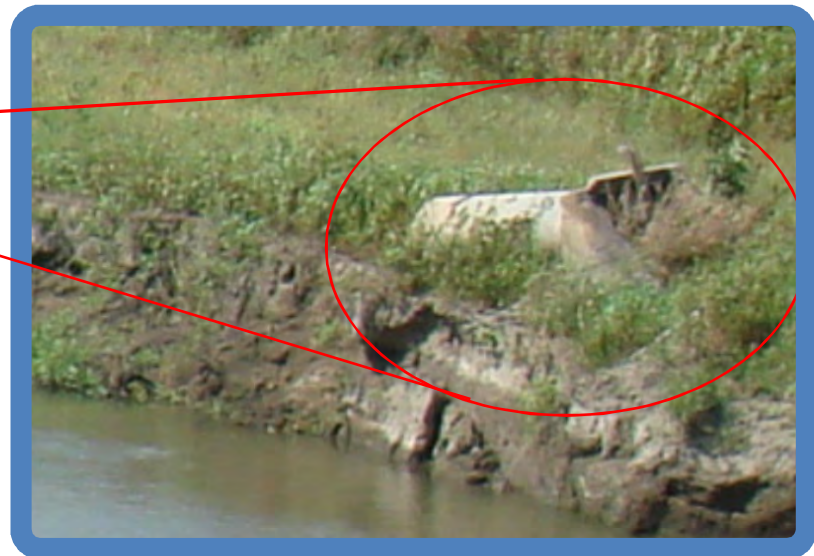
The structural stability of the perimeter dikes impounding the ash ponds appears adequate with respect to global stability under static and seismic (pseudo-static) loading conditions and with respect to liquefaction potential. The slough that was observed on the outside slope of the levee on the north side of the South Ash Pond appears to have been caused by loss of toe support due to erosion during flood flows in Pony Creek and not due to inherent instability of the levee section.

Photo O.3
Pony Creek levee outside slope South Pond (N side viewed W)

The draft report identified issues concerning the slump on the levee (outside slope of dike on north side of South Ash Pond) and damaged end of outlet pipe from the North Ash Pond. Subsequent repairs have been made, so no action is required by MidAmerican, other than visual monitoring.
